New anode for cathodic protection of car parks

Franz Pruckner, ex-Protector, Pressbaum, Austria and John Broomfield, Broomfield Consultants, Surrey, UK

Case study

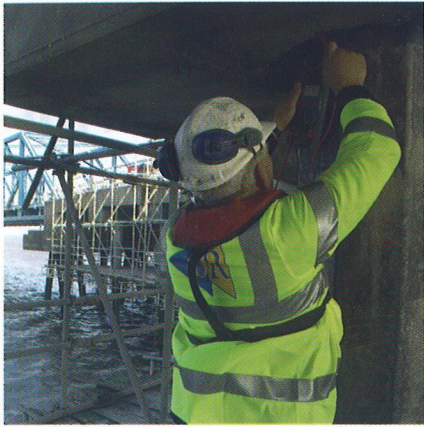
Figure 3: An engineer tests the electrical resistance of a cathode in the ICCP system at the Stena Ro-Ro terminal, Fleetwood.

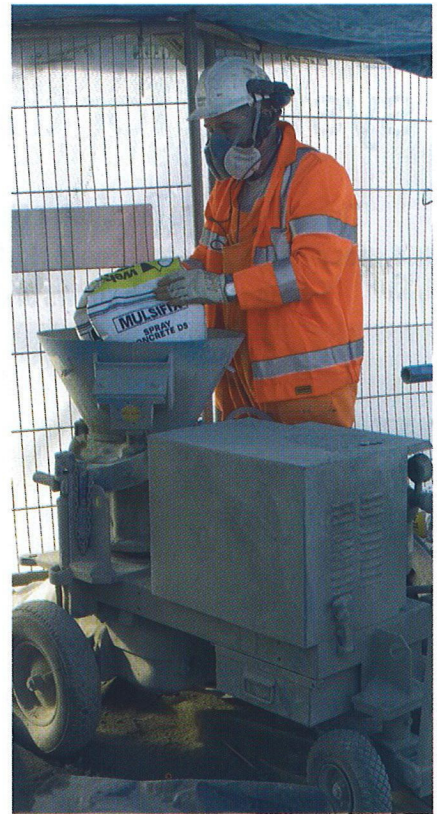
Figure 4: An operative charges the spray concrete machine for pumping to a remote application point.

Dry spray-applied concrete was used for the repair to the reinforced structural elements.

The proprietary bagged material was pumped in its dry powder state over distances of up to 200m through the areas of the temporary working platform. Water was added only at the spray nozzle. This method meant that works which required continuous start-and-stop routines were accommodated without material setting in the spray lines. The compressed air-driven spray equipment enabled a very high velocity of placement, ensuring high compaction and density. Modern materials are capable of strengths in excess of 50MPa and with this process shuttering is almost entirely eliminated. An excellent steel float finish was achieved with complex profiles where required.

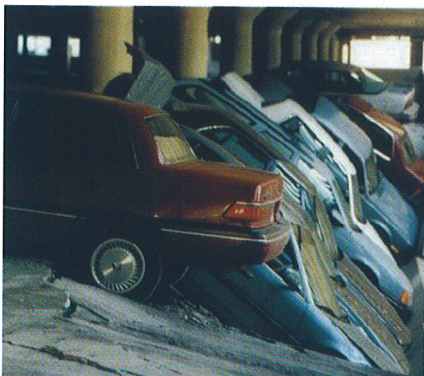
Figure 1: The MONY car park, Syracuse NY which collapsed without personal injury due to reinforcement corrosion.

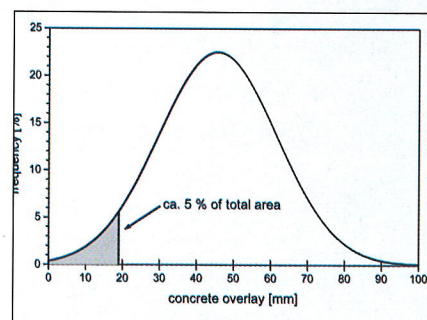
Figure 5: Combination of concrete cover and carbonation measurements: 5% of the reinforcement is lying in carbonated concrete.

The minimum depth measured on the cores was 17×4 mm and the maximum depth 21×3 mm (see Figure 4). When taking the average carbonation depth of 19 mm, together with the distribution of concrete cover measurements, it can be concluded that approximately 5% of all top reinforcement was situated in carbonated concrete (see Figure 5). Carrying out electrical resistance checks between reinforcing bars according to EN 12696: 2002⁽⁶⁾, showed that there was considerable discontinuity which would require bonding during installation of the ICCP system.

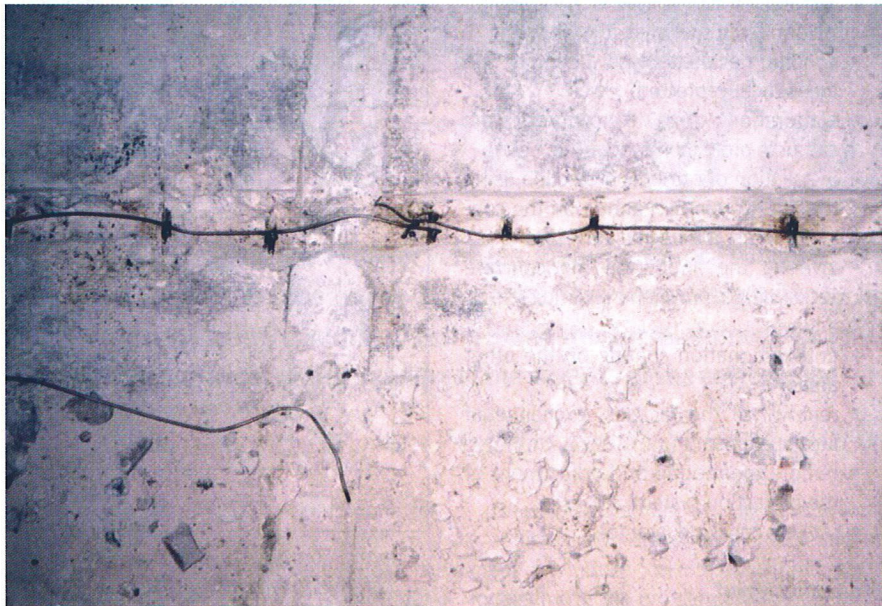
Figure 7: Establishing electrical continuity between the reinforcing bars.

Figures 6 and 7 show the extent of the delaminations found after removing loose concrete, and the installation of a welded steel wire to make electrical continuity between bars to carry the impressed current back to the negative terminal of the d.c. power supply. The location of the embedded reference electrodes is shown in Figure 8. These were the most anodic locations identified by the reference electrode potential survey.

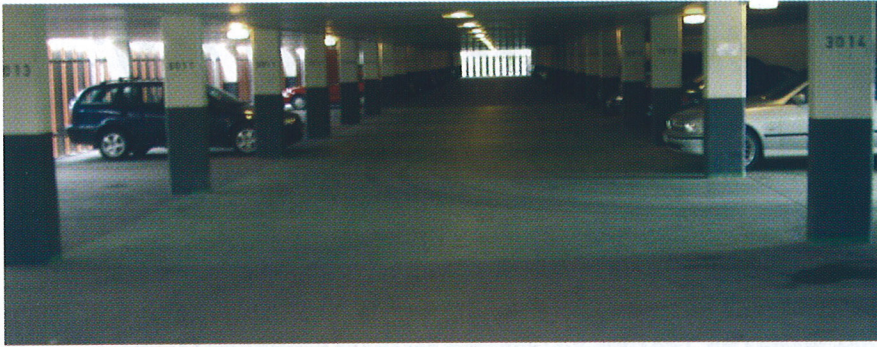
Figure 10: The car park after application of the water-resisting layer.

The application of the anode system is shown in Figure 9. Primary anode wires are fixed in recesses in the deck, conductive coating is applied over them and in strips between them. This maximised the adhesion of the waterproofing layer to give the finished product shown in Figure 10. The conductive coating is specially formulated so that the binder is conductive as well as the carbon pigmentation. This leads to a very low applied current as can be seen in Figure 11 and a good degree of polarisation with a very modest average current density. The seasonal fluctuation in temperature, current and concrete resistivity can be clearly seen in Figure 11.

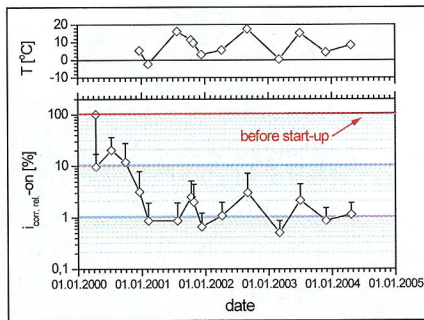
Figure 13: Course of the average relative corrosion rate of the reinforcement in level three for the current being switched on with time of CP.

Tafel-constants determined prior to CP and generate the average value. When achieving a depolarisation value of one Tafel constant, the corrosion rate equals 10% of the unprotected steel, and at a value of two Tafel-constants the steel is nominally corroding at only 1% of its unprotected value. In Figure 13, the course of the corrosion rate over the period 2000–2004 is shown as a percentage of the initial value before energisation. At start-up, the corrosion rate was reduced to 10% of the original, and then after a few months by two orders of magnitude to approximately 1% of the original corrosion rate.
